Manhole Inspection Summary

Manhole # S37Y1_013MH

Insp Date: **12/13/07 1:29 PM**

Location Address: **325 Washburn St**

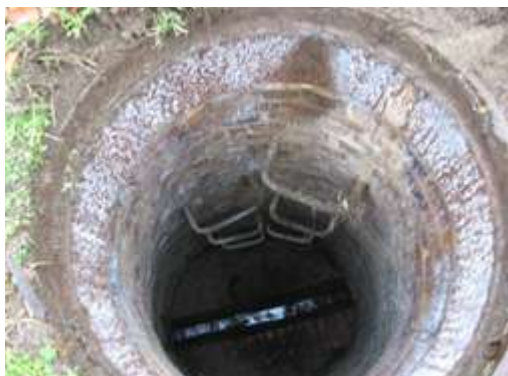
Steps Count: **6** Missing: **0** ☐ Corroded

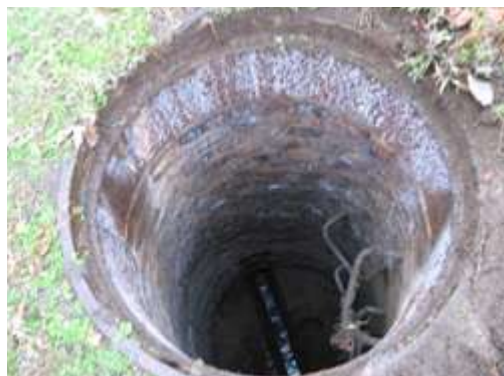
Defect 1

Infiltration: ☐ None ☐ Joint ☐ Cracks ☐ Mortar ☐ Roots ☒ **Wall**

Wall

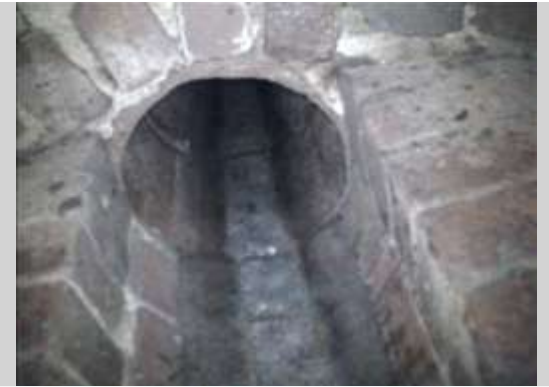
12 O'Clock Outflow

8 in. Circular Gravity Sewer
Pipe Out @ 12 O'Clock

Pipe Height: **10.8** (in.) Rod and Bar (Angled)
Pipe Material: **Clay** ☐ Pipe Lined
Invert Depth: **10.04** (ft.) Flow Characteristics: **Fast**
Deposits: ☒ None ☐ Mud ☐ Sludge ☐ Debris ☐ Grease
Silt Depth: (in.) Deposits Extent:
Infiltration: **None** Pipe Seal Cond: **Sound**

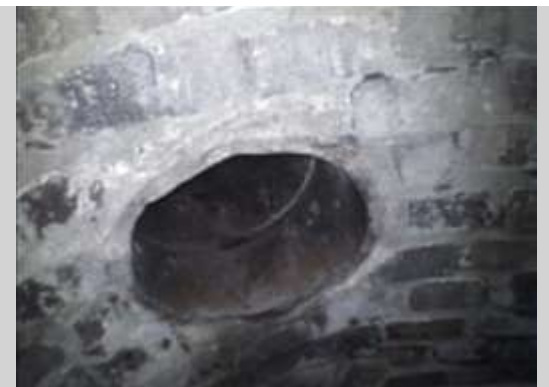
6 O'Clock Inflow

8 in. Circular Gravity Sewer
Pipe In @ 6 O'Clock

Pipe Height: **10.8** (in.) Rod and Bar (Angled)
Pipe Material: **Clay** ☐ Pipe Lined
Invert Depth: **8.28** (ft.) Flow Characteristics: **Fast**
Deposits: ☒ None ☐ Mud ☐ Sludge ☐ Debris ☐ Grease
Silt Depth: (in.) Deposits Extent:
Infiltration: **None** Pipe Seal Cond: **Sound**

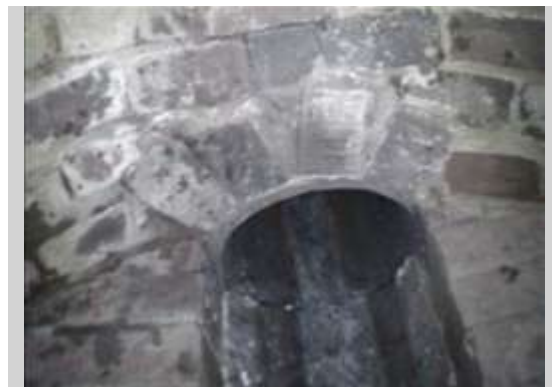
Drop In @ 6 O'Clock

Drop: **Outside** Rod and Bar
Angled: **Yes** Reading: **8.76** (ft.)
Inv Depth: **9.76** (ft.)
Drop Condition: **Open**
